Retrofit for the Future Final Phase Report ZA522P Appendix 2 Construction photographs

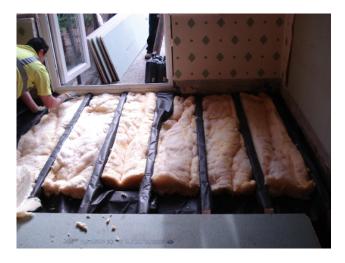
$150 mm\ of\ mineral\ wool\ insulation\ fitted\ between\ floor\ joists$

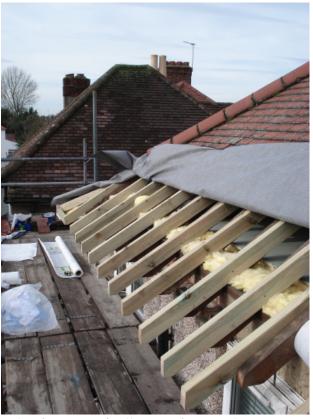
High performance PUR fitted between rafter to provide a continuous insulated envelope over the top of the external walls.

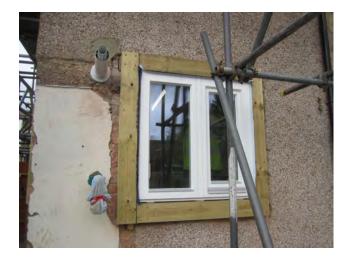
Installing triple glazed passivhaus windows with timber surround

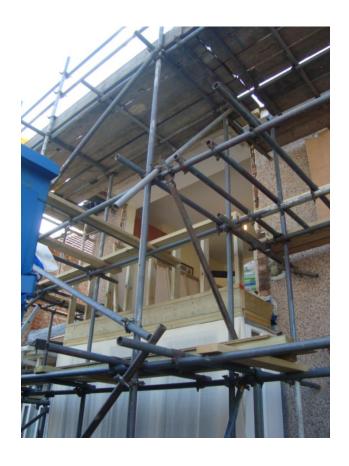
$Timber\, frame\, construction\, of\, bay\, window\, area$
